FairfieldCity
Celebrating diversity

ASSET MANAGEMENT PLAN COMMUNITY BUILDINGS

INTEGRATED PLANNING AND
REPORTING FRAMEWORK

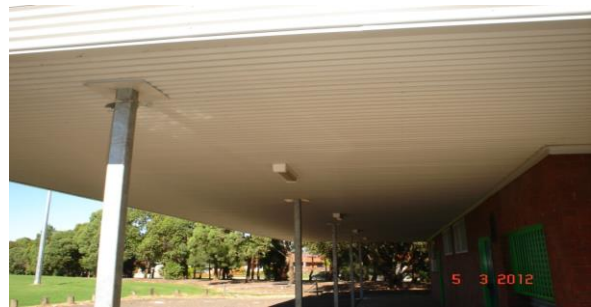
Roof

Condition 1: No work required (normal maintenance)

Level	Condition	Description	% Life Consumed
1	Excellent	No work required (normal maintenance)	0
2	Good	Only minor work required	25
3	Average	Some work required	50
4	Poor	Some renovation needed within 1 year	75
5	Very Poor	Urgent renovation/upgrading required	100

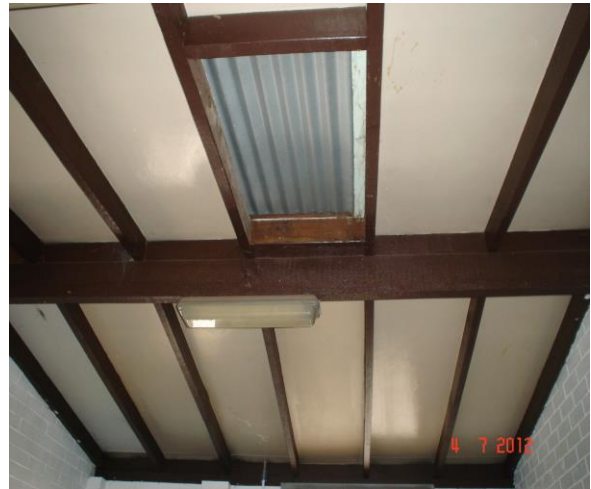
Roof

Condition 2: Only minor work required

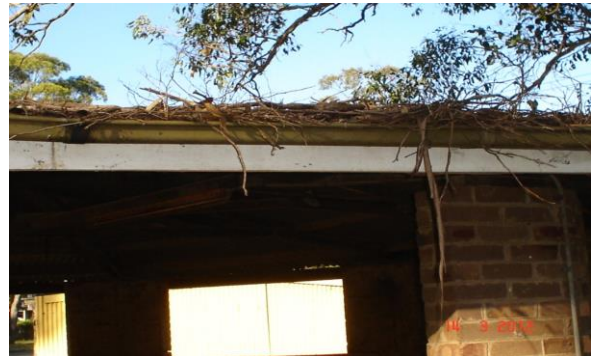
Roof

Condition 3: Some work required

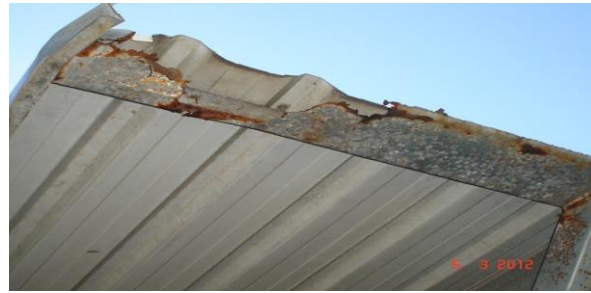
Roof

Condition 4: Some renovation needed within 1 year

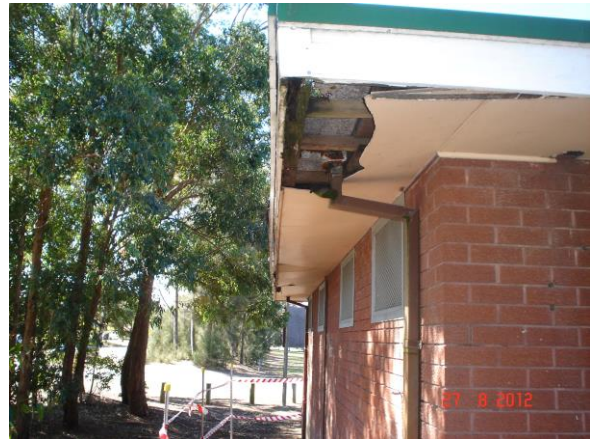
Roof

Condition 5: Urgent renovation/upgrading required

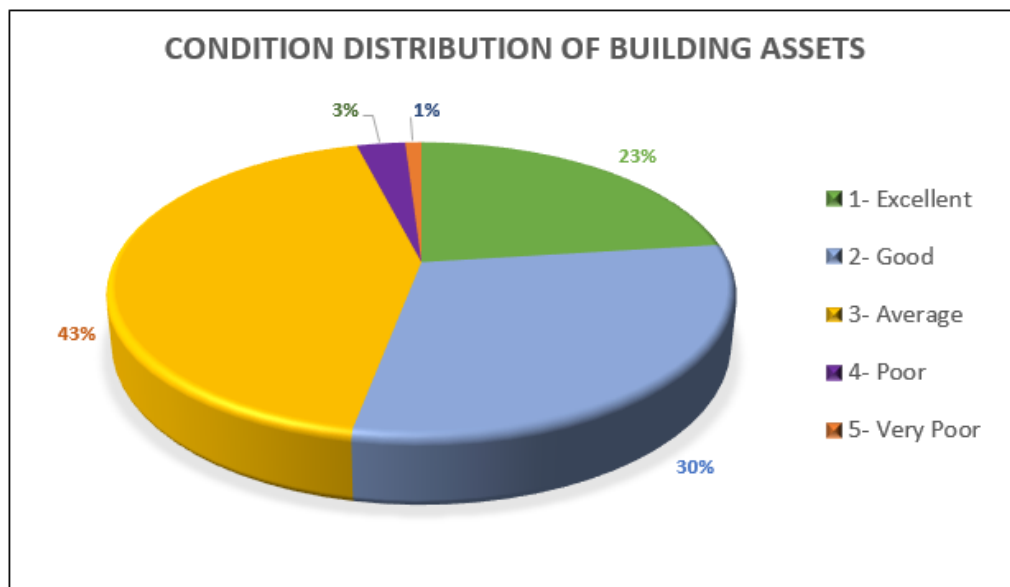
The most recent condition profile is shown in the below graph:

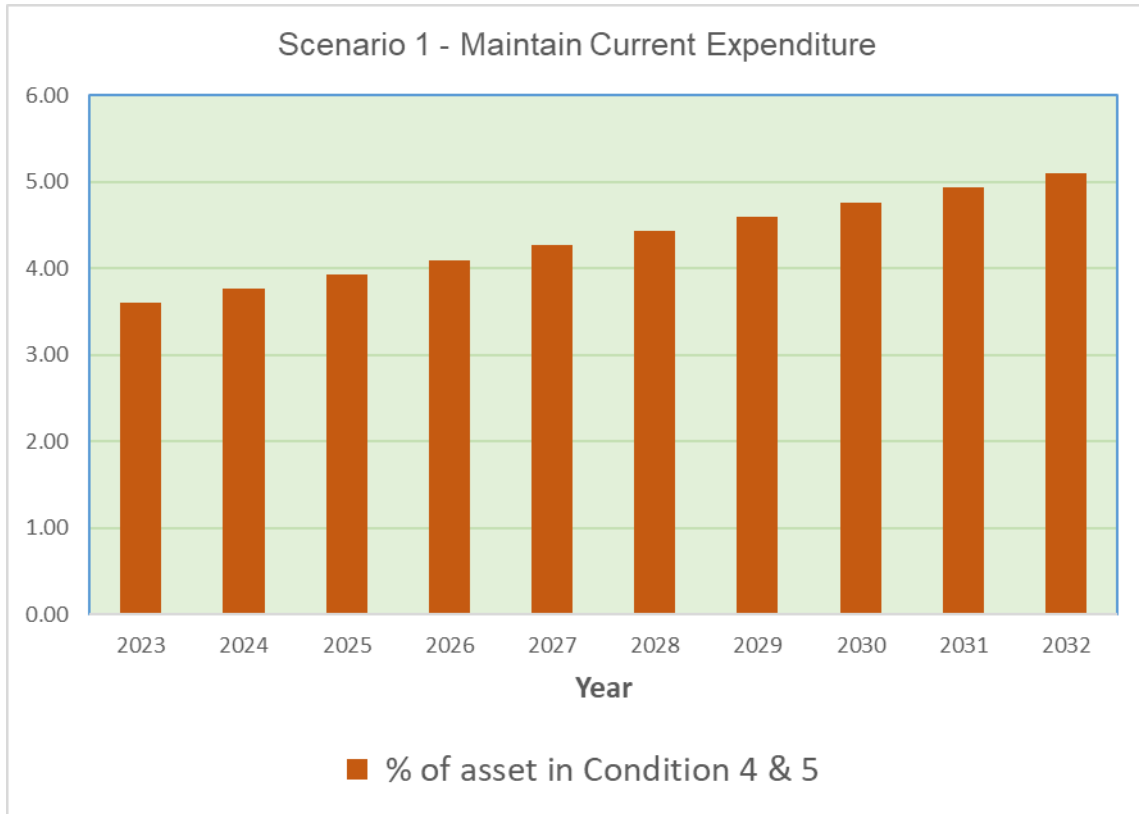
Scenario 1: Maintain Current Expenditure:

With a current level of funding, the average building condition will fall to 2.4 and the asset base will rise to 5.1% at conditions 4 and 5 in 10 years.
